LAKE ONEIDA DAM
NDI No. PA - 272

PHASE I INSPECTION REPORT

NATIONAL DAM INSPECTION PROGRAM .

SEPTEMBER 1978

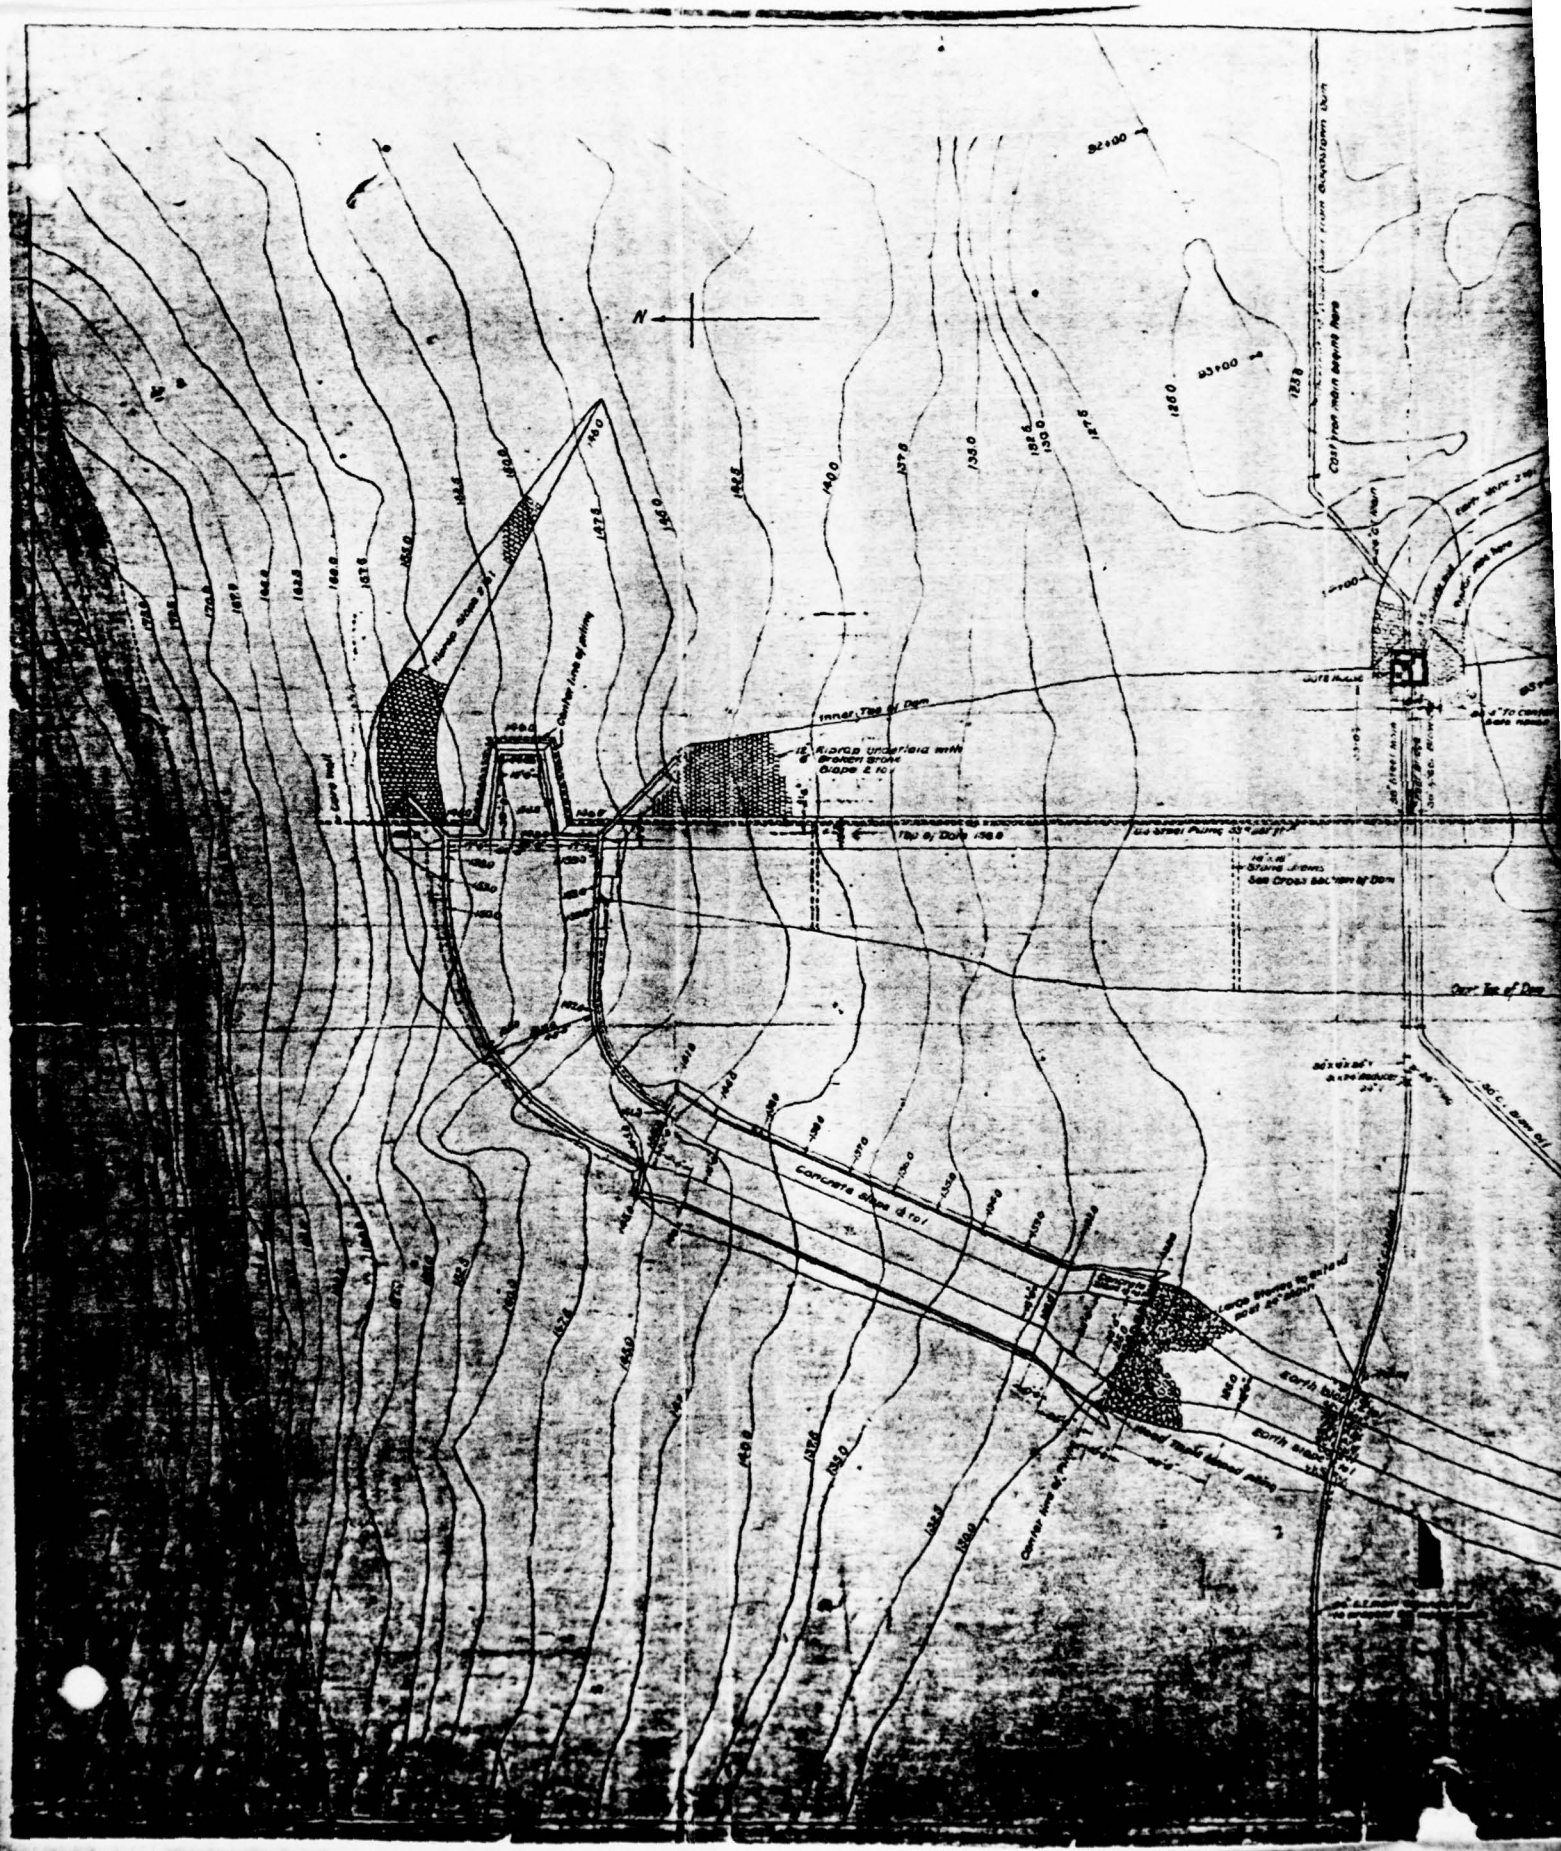
FIGURE 1

Saturated conditions were observed at the toe of the dam in a few areas (see Figure 1). These areas of seepage have been noted in PennDER files since shortly after the embankment was constructed. Flow could not be measured; however, the condition warrants further investigation by a geotechnical engineering experienced in dam design.

ii. Investigate and determine the cause of the seepage observed at the downstream toe of the embankment, the piping potential, and to recommend remedial measures if necessary.

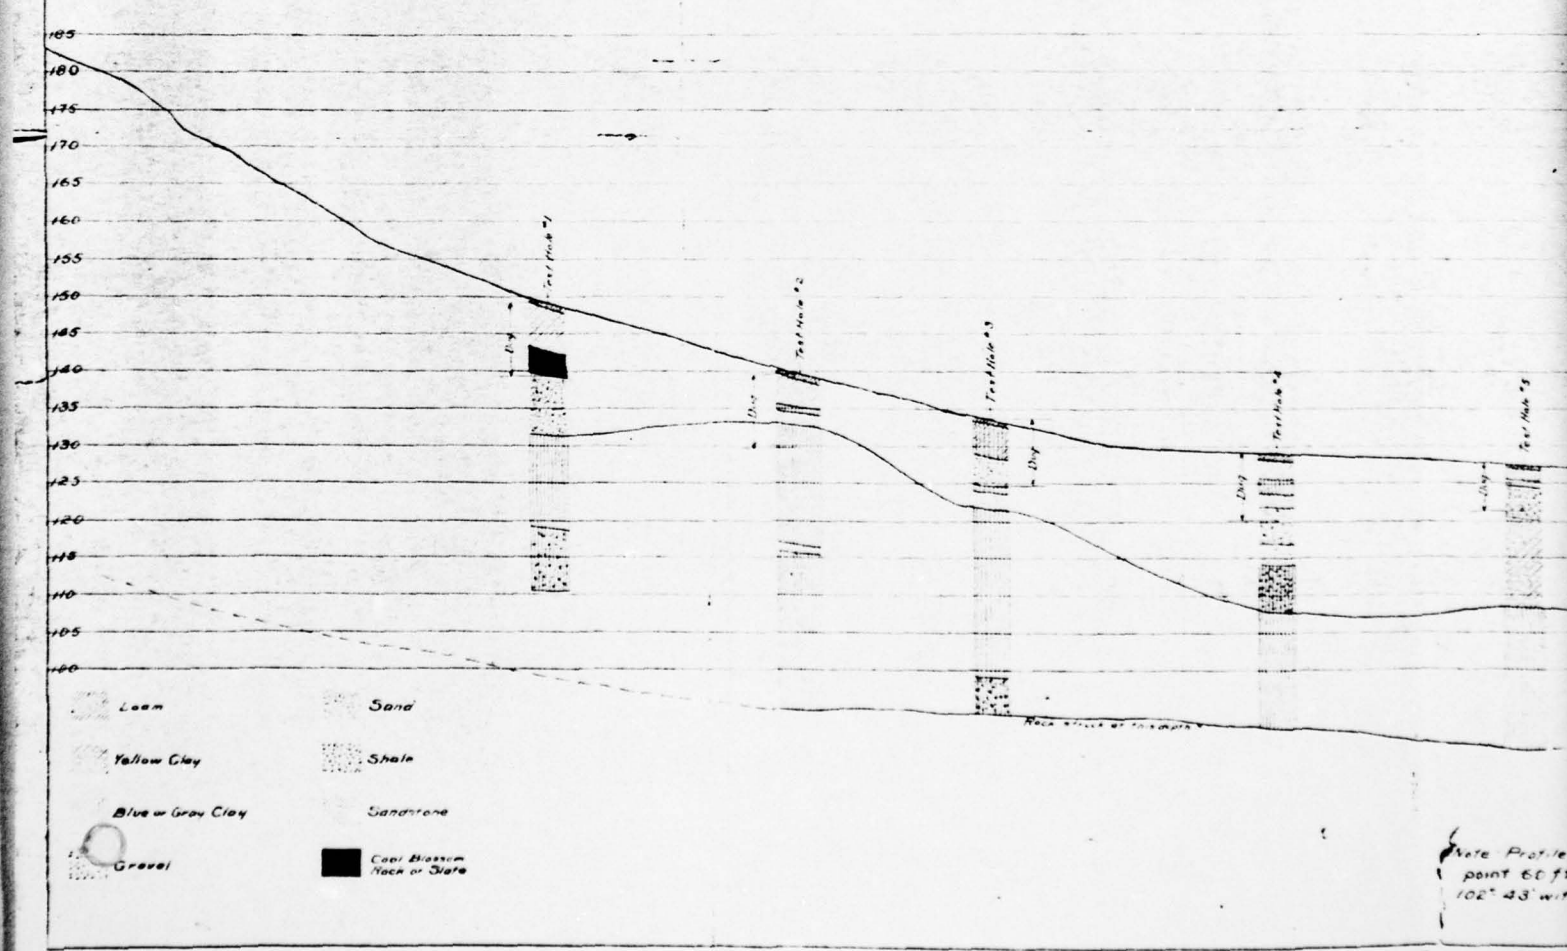
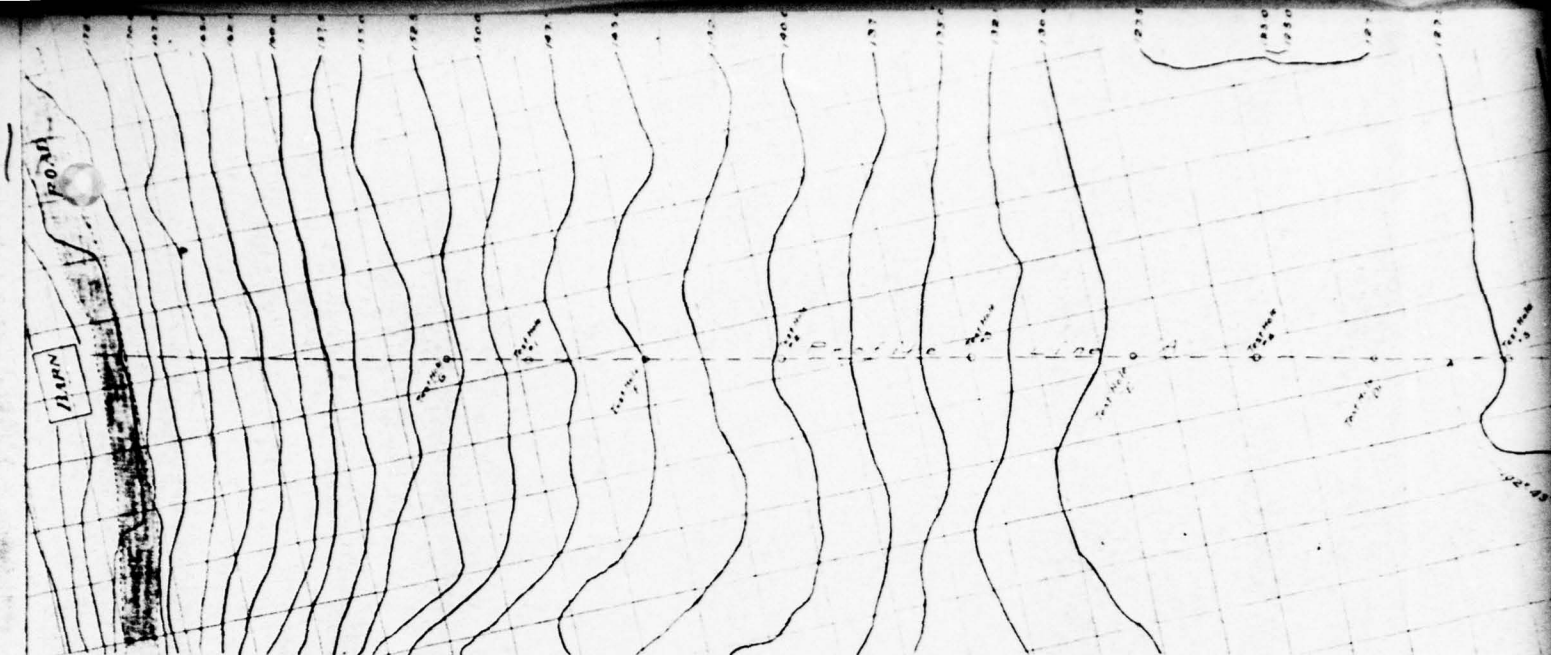
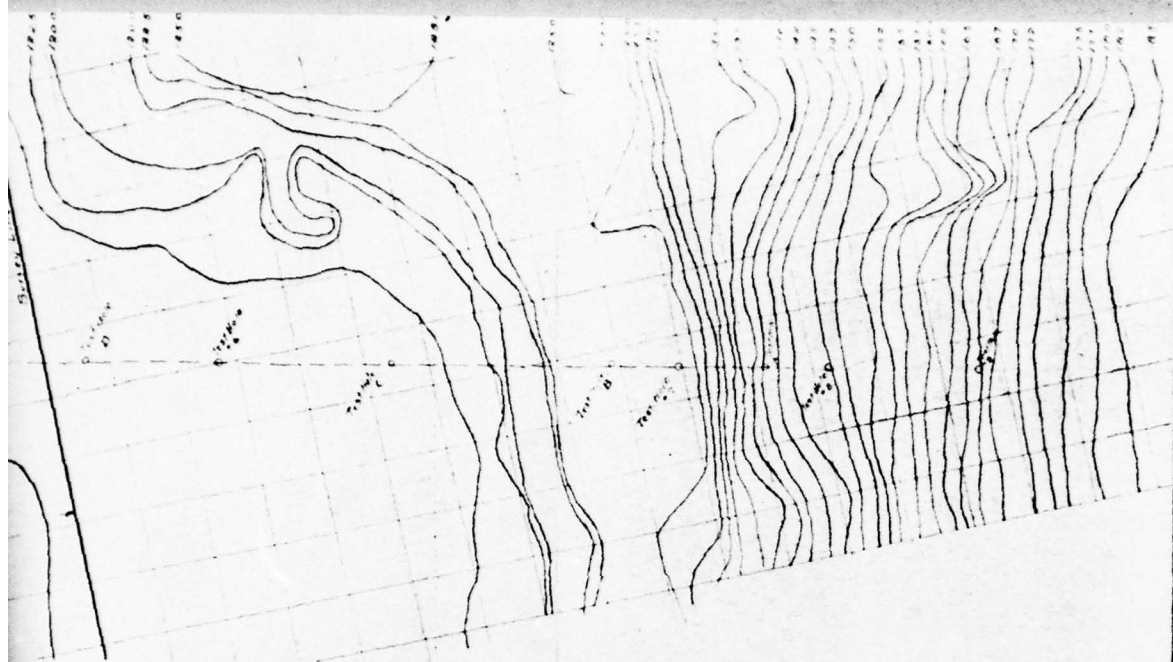
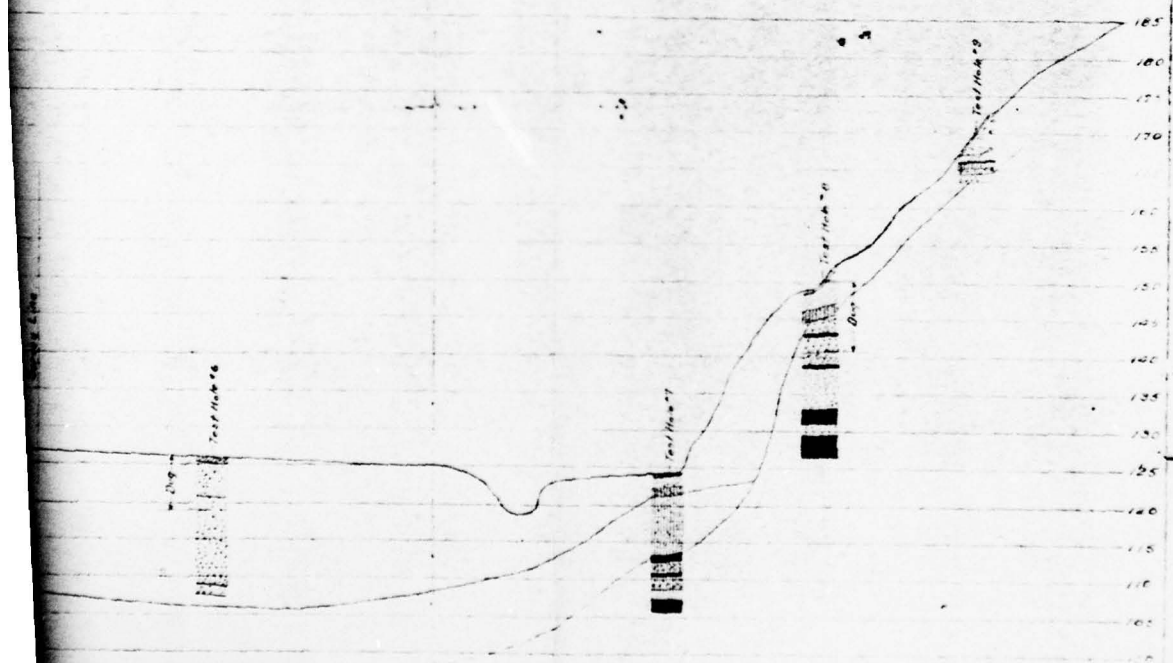
BUTLER, PA. **FIGURE 7**
 CONTOUR AND CROSS SECTION
 OF
 LAKE ONEIDA DAM

1. Embankment. Contract drawings, specifications, and inspection reports (all available in PennDER files) indicate the embankment is a rolled earthfill structure containing a reinforced concrete corewall underlain by interlocking steel sheetpiling. Contract drawings and the visual inspection indicate that the upstream and downstream faces are sloped at 2H:1V. Drawings and specifications indicate that four 18- x 18-inch stonefilled drainage laterals were constructed from the corewall to the downstream toe. Field inspection indicates that these drains may be directed into drain tile that discharges into the natural stream channel. Contract drawings indicate that the steel piling extends about 20 feet below the base of the corewall, probably penetrating the clay strata indicated by the geologic cross section. (See Figure 7).
